*The Church of Hagia Sophia in Bizye (Vize): Results
of the Fieldwork Seasons 2003 and 2004*

Franz Alto Bauer and Holger A. Klein

History and State of Preservation

Preliminary Results of the 2003 and 2004 Fieldwork Seasons

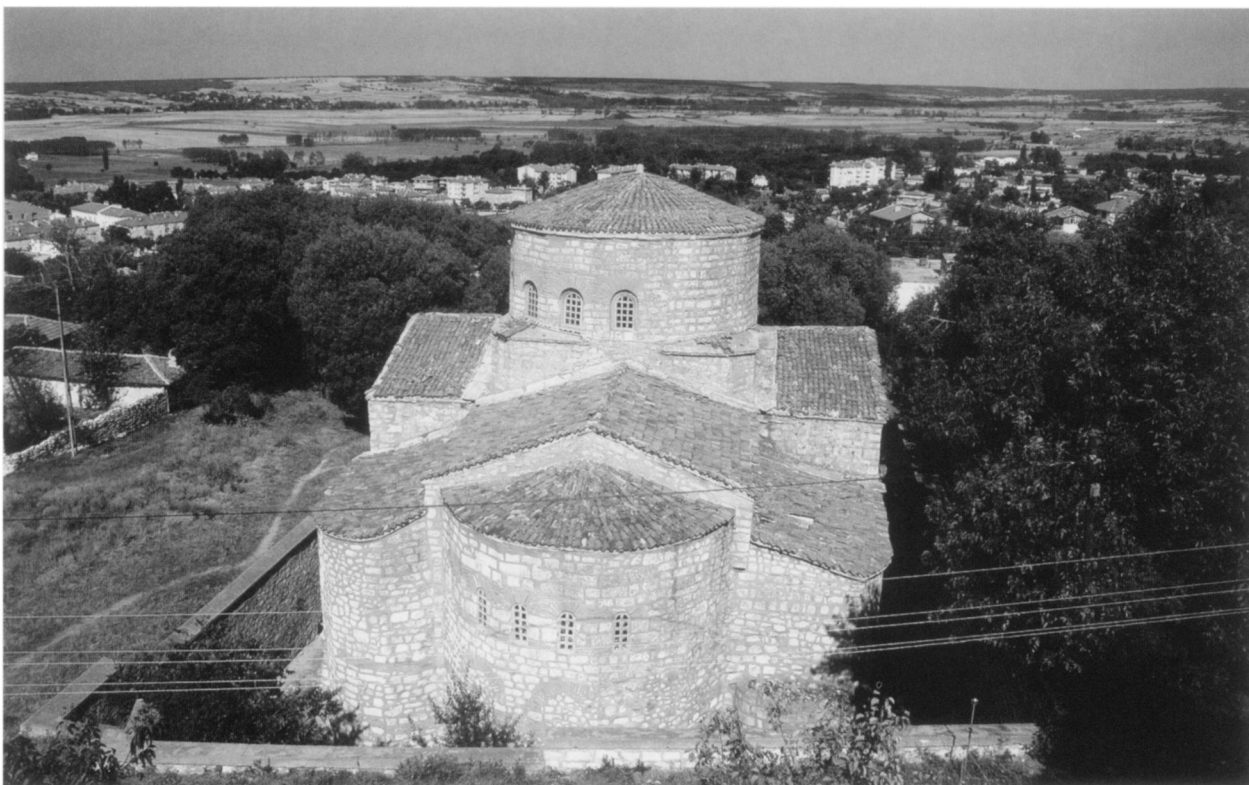
Fig. 3 Vize, Hagia Sophia, exterior from east, 2004 (photo: R. Rosenbauer)

resulted in some unfortunate interventions and led to the destruction of valuable archaeological evidence inside and outside of the church. Due to financial difficulties and complaints from the Vize Belediyesi, work was eventually abandoned in 1983 and the restoration of the building was left partly unfinished.²⁵ As far as can be ascertained from what is visible today (fig. 3), the restoration work that was carried out under the supervision of Erol Çetin of the İstanbul Vakıflar Bölge Müdürlüğü followed three main objectives: (1) the removal of earth that had washed down from the hill of the acropolis for centuries and had built up around the church to a maximum height of over ten meters at its eastern end (fig. 4);²⁶ (2) the restoration of the building's "original" appearance on the exterior, which involved the opening of three tympanum windows on the north and south façades to their (presumably) original size, as well as the repair and pointing

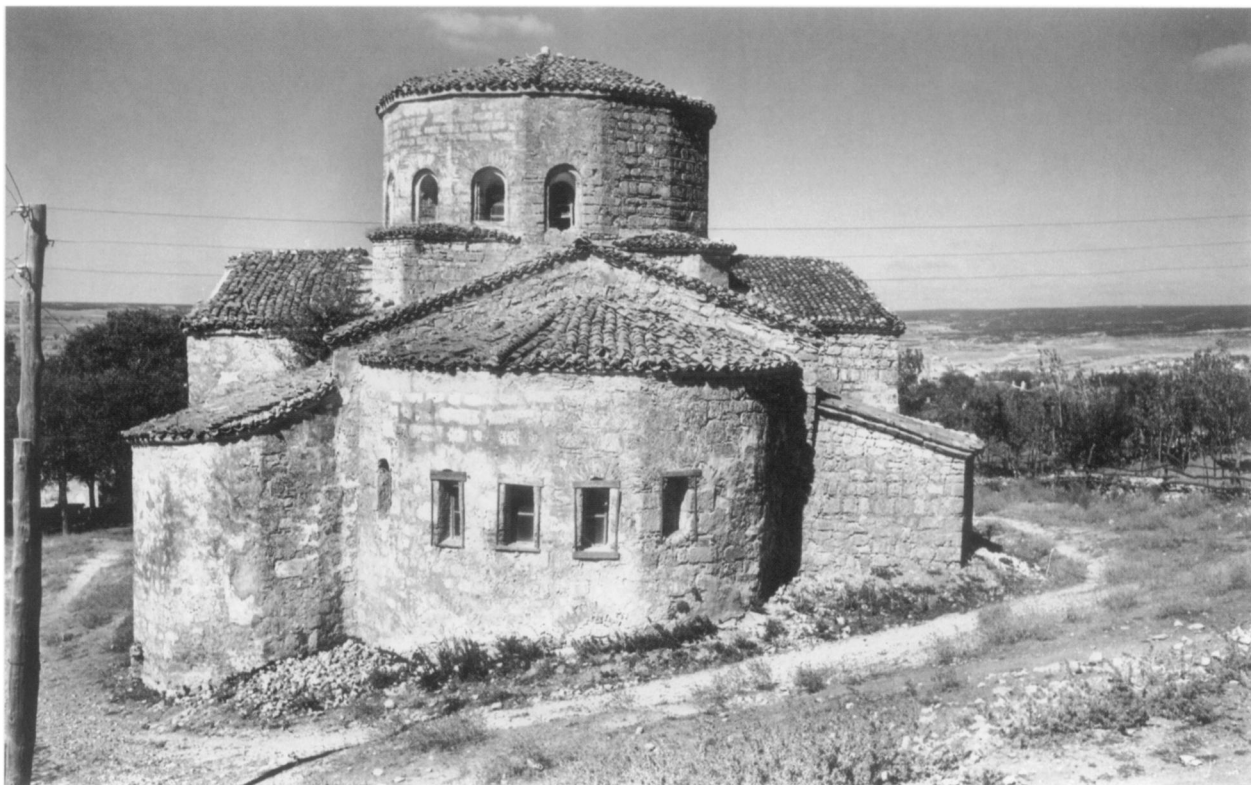
restoration show the extent of earth accumulation, especially on the building's south and east façade. See Mango, "Byzantine Church," figs. 1 and 2. The removal of earth was accompanied by the building of large retaining walls on the north, south, and east sides of the church. The excavated material was moved to the area west of the church, where it was piled up to create large mounds.

Fig. 4 Vize, Hagia Sophia, exterior from east, ca. 1960 (photo: C. Mango)

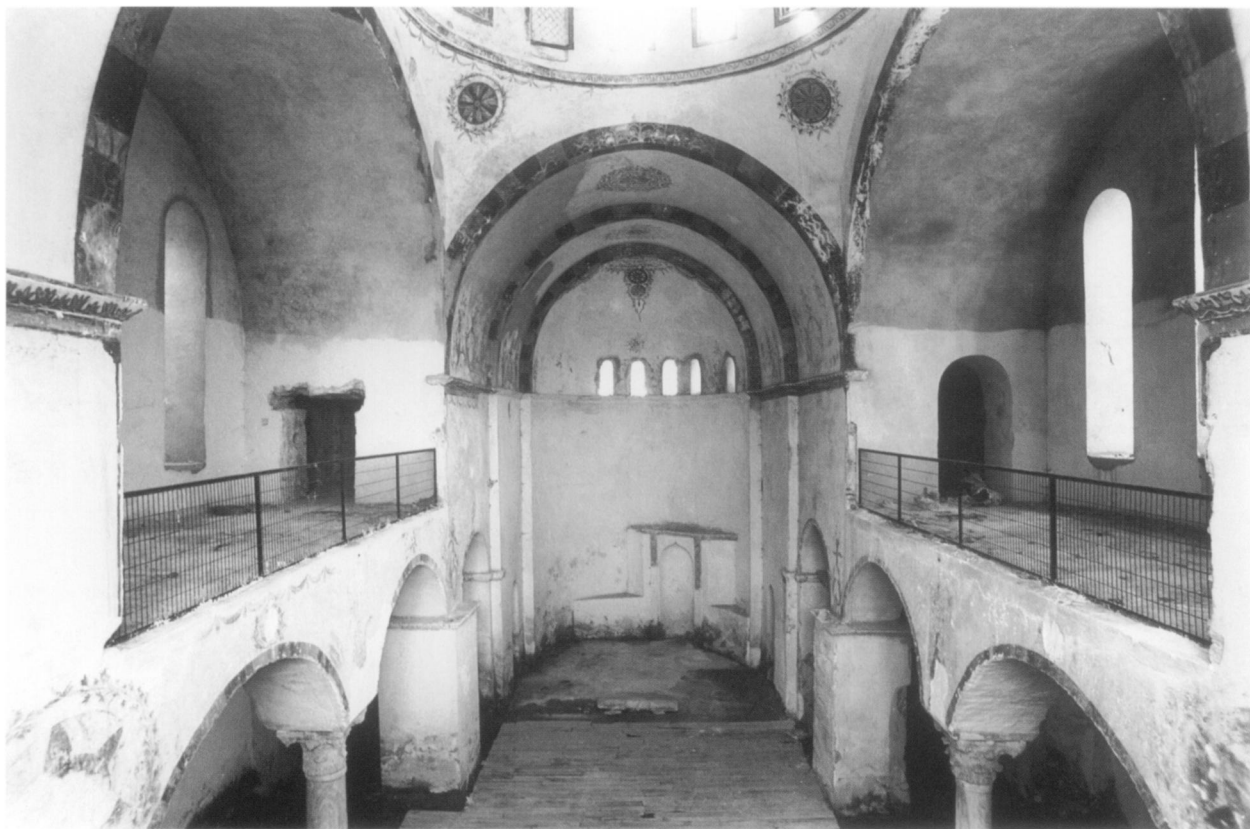
up of joints between brick courses and stones on the building's north, south, and east façades;²⁷ (3) the restoration of the building's "original" appearance on the interior, which involved the removal of the raised Ottoman marble and opus sectile floor as well as the replastering of much of the unpainted wall surfaces, corner piers, and tympanum arches over the south and north galleries (figs. 5–6).²⁸

Fig. 5 Vize, Hagia Sophia, interior toward east, 2003 (photo: R. Rosenbauer)

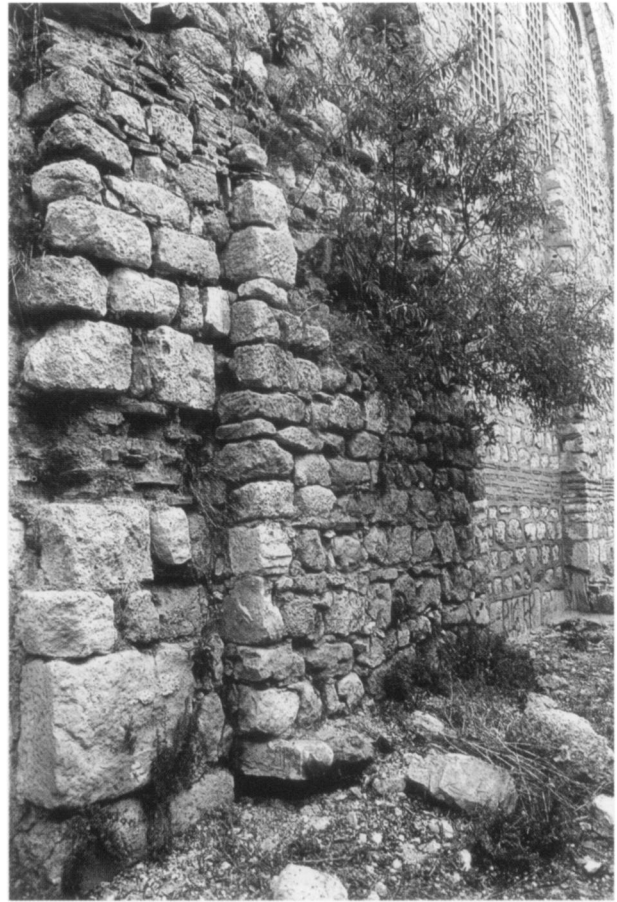
presumably the result of an earthquake—seems to have been extensive.⁴² This at least is suggested by evidence for a complete rebuilding of the northeastern gallery chapel and the upper parts of the northern half of the central apse, which now lacks two of its originally seven windows.⁴³ On the lower level, the central apse once featured three large windows, which were subsequently blocked, most likely by an increased accumulation of earth at the eastern end of the church.⁴⁴ Small irregularities in the outer skin of the side apses further suggest that these, too, once featured windows on both the ground and gallery levels.⁴⁵ Other changes to the building's original fabric are clearly visible on the exterior of the south façade. At some point in the Byzantine period, an arcosolium tomb was added in the westernmost bay of the south side aisle. Unlike the arcosolium in the third bay of the south aisle, which forms an integral part of the wall and thus an integral part of the original building, the western arcosolium was clearly an afterthought that involved not only the partial opening of the south wall but also the addition of a reinforcement wall on the exterior (fig. 11).⁴⁶ A still-puzzling feature is the blocked archway and an adjacent wall fragment that protrudes southward at the eastern end of the south façade (fig. 12). It may be assumed that the archway once connected the diakonikon with an adjacent room or chapel to the south, but this claim cannot be verified at present.

Fig. 11 Vize, Hagia Sophia, south façade, detail of reinforcement wall behind west arcosolium

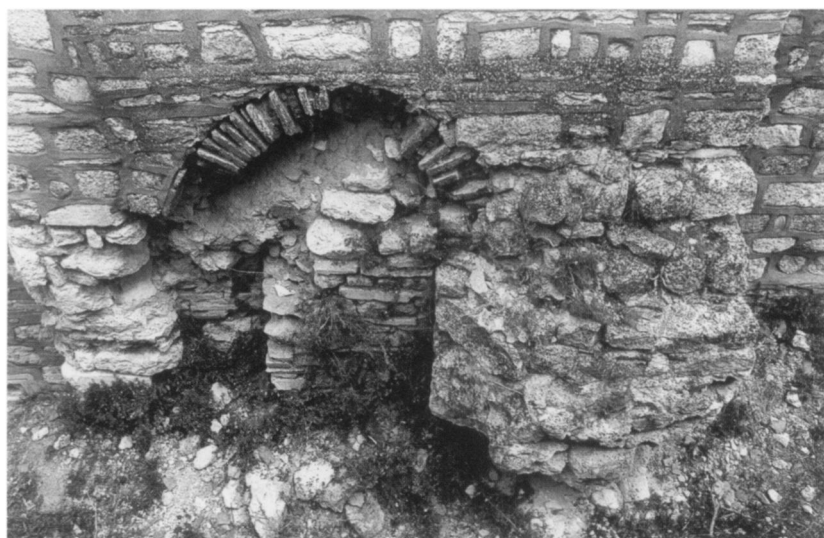
Fig. 12 Vize, Hagia Sophia, south façade, wall protruding south with blocked archway

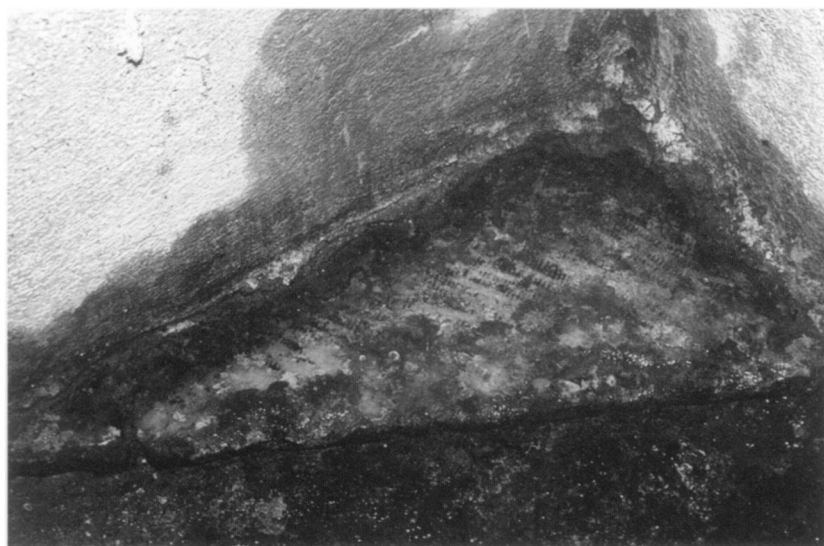
In the interior, the removal of the Ottoman marble floor during the Vakıflar restoration exposed fragments of the original Byzantine floor in the sanctuary and the corners of the side chapels (fig. 13). Furthermore, a row of greenish marble blocks was uncovered, which once defined the limits of the sanctuary (fig. 14). Traces of dowel holes

Fig. 13 Vize, Hagia Sophia, diakonikon, fragment of original marble floor
